### 9.2.1 Electric Line Clearance Compliance: Street Tree Management

**Whitehorse CC ELC System Audit Report**

## Electricity Safety (Electric Line Clearance) Regulations 2015 – System Audit Report for the City of Whitehorse

## 9.2.1 – ATTACHMENT 2. ELC LBRA Inspection Report

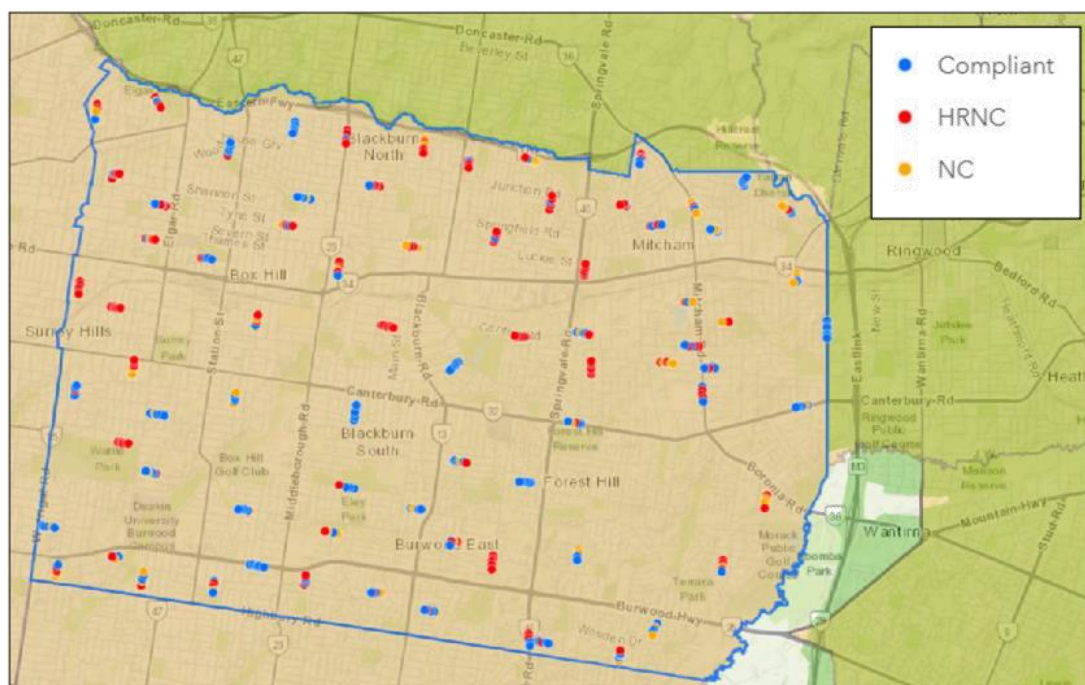
**Figure 2: Location of all identified Compliant, NC and HRNC spans in the City of Whitehorse Declared LBRA**

ESV inspected a total of 380 spans. Of these spans, 218 were found to be affected by vegetation that did not comply with the requirements of the code and where the City of Whitehorse is responsible for maintaining the minimum clearance space.

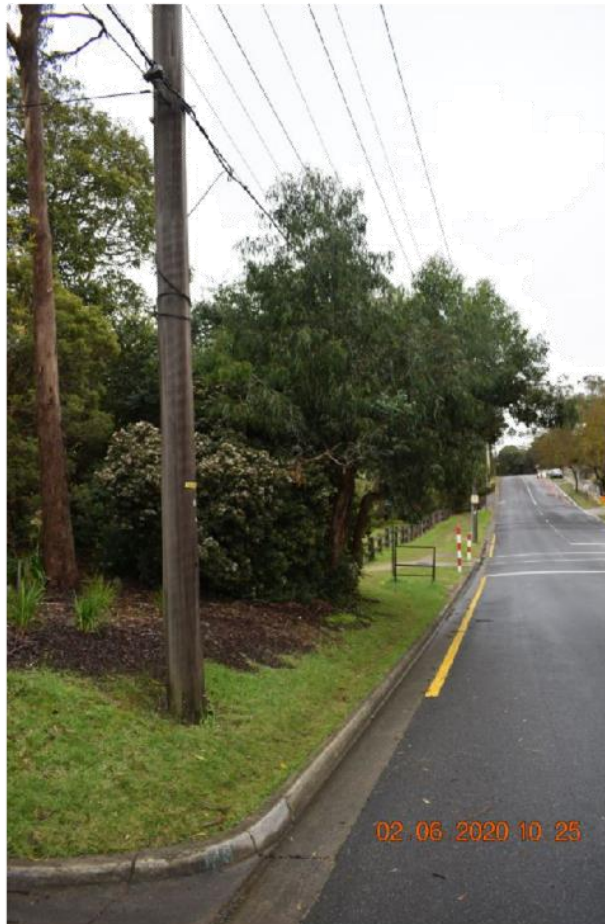
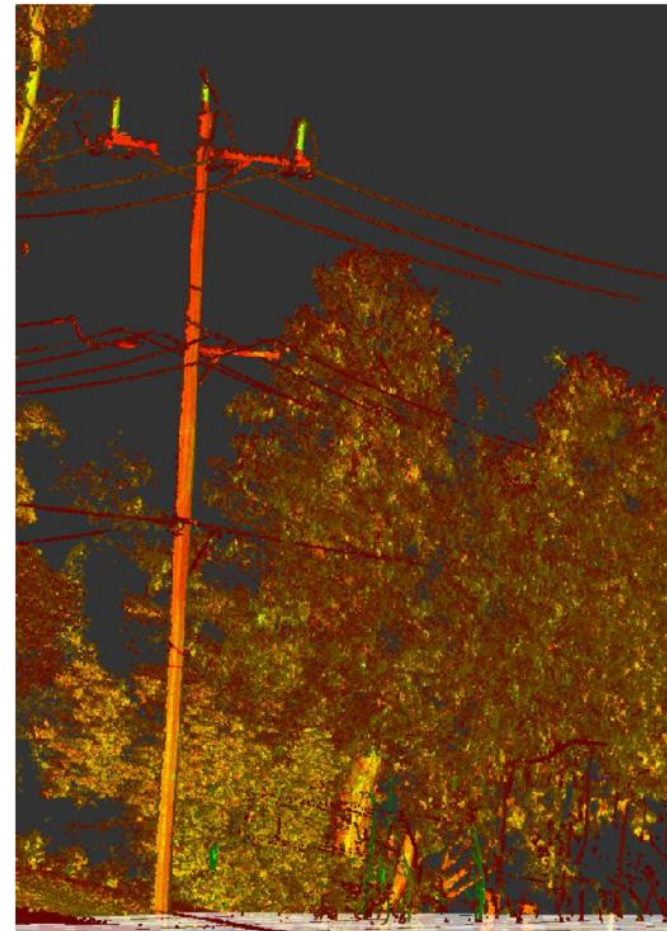
148 Central Rd, Nunawading

Examples of trees that were found to be contacting electric lines are shown in the photographs and LiDAR scans within Annex B of this report.
