Arboricultural Report

(Development Impact Assessment)

For the Proposed Development of
39-41 Holland Road,
Blackburn South 3130

23rd September 2020

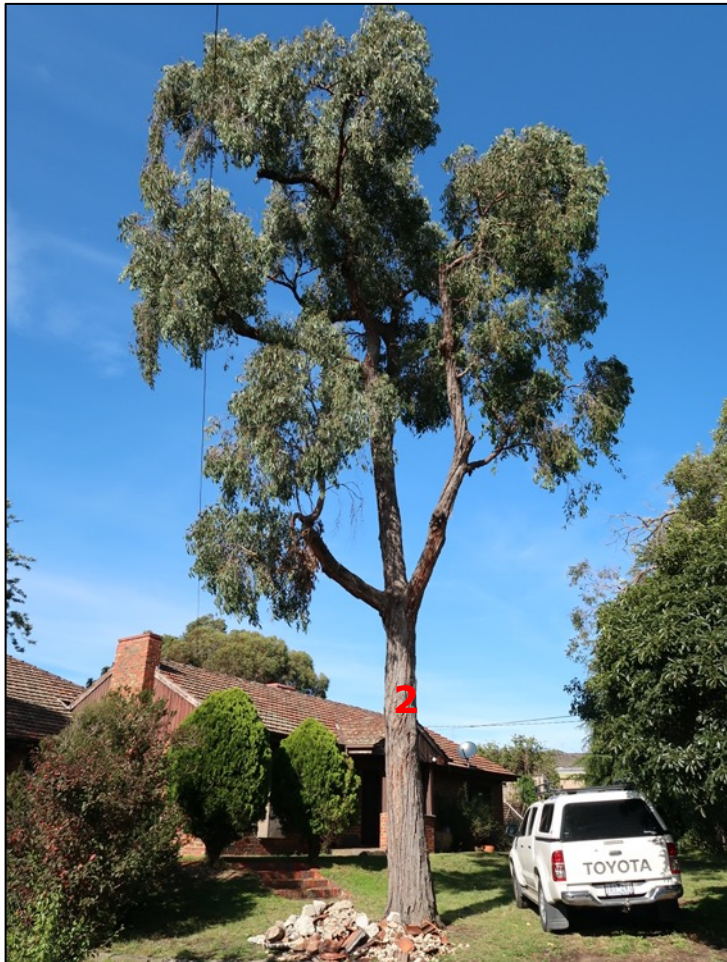
Photo One: Tree 2 showing general condition, architecture, landscape contribution, and existing features in the TPZ.

Trees 2 & 4 are Messmate of varied condition (See Photo One). **Tree 2** adds moderate site character and habitat value, **Tree 4** is senescing and unsuitable for retention regardless of development (See Photo One).

Tree 2 has some prior wounds/pruning which may be indicative of a limited ULE, but retention is recommended because of its landscape prominence and overlay values. **Tree 2** incurs a major TPZ encroachment (approx. 14%), paving in the SRZ is recommended to be removed to minimise disturbance where large/structural roots will exist. **Tree 2** should remain viable with

fencing/ground protection as access requires, plus irrigation of the fenced area (See Recommendations & Appendix 2).

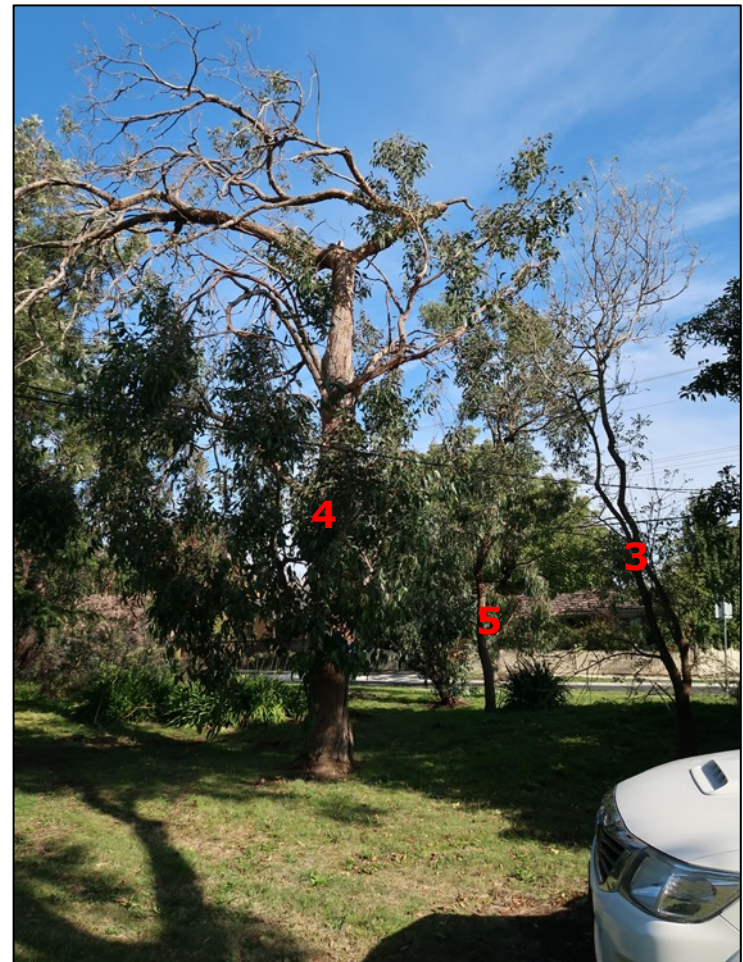
Photo Two: Tree 4 has extensive dieback. Removal of **Trees 3-5** is supported.

Trees 5-8 & 12 are all semi-mature native trees, mostly of inferior quality (See Photos Two-Six & Thirteen). **Trees 5-8** would all require extensive pruning to make long-term retention appropriate, **Tree 12** has a limited ULE. **Trees 5 & 6** require removal for a new driveway, others could be retained. Removal of all five trees is proposed/supported given the retention of several mature trees and capacity to replace it with superior quality stock. Inclusion of new trees has been incorporated to plans to offset the removal of **Trees 5-8** (See Recommendations & Appendix 6).

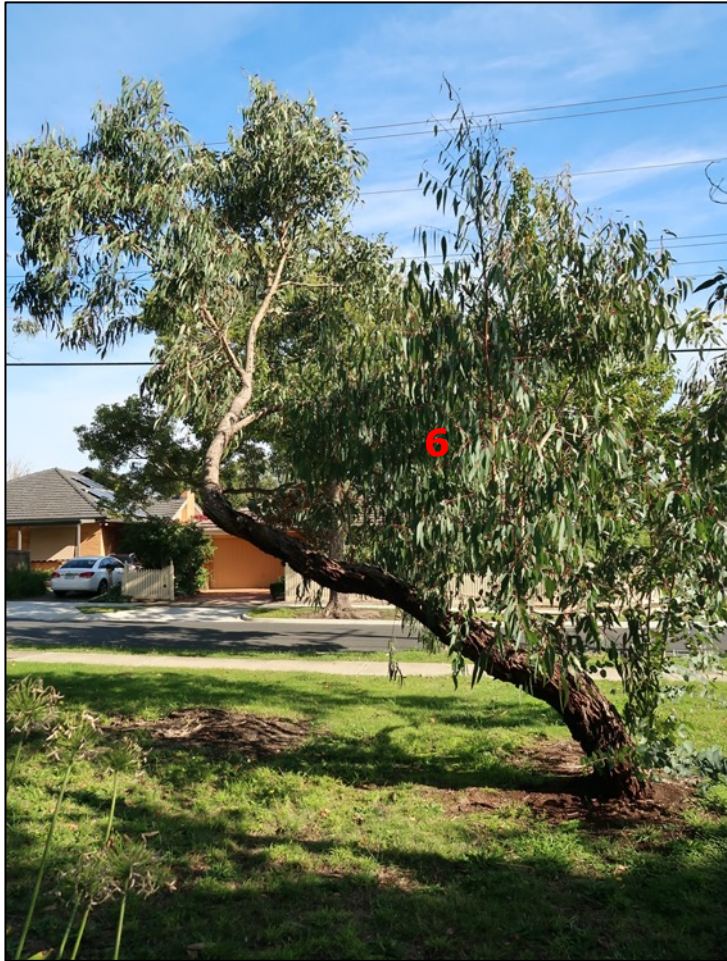
Photo Three: Tree 6 is not on plans, it has poor architecture making removal appropriate.

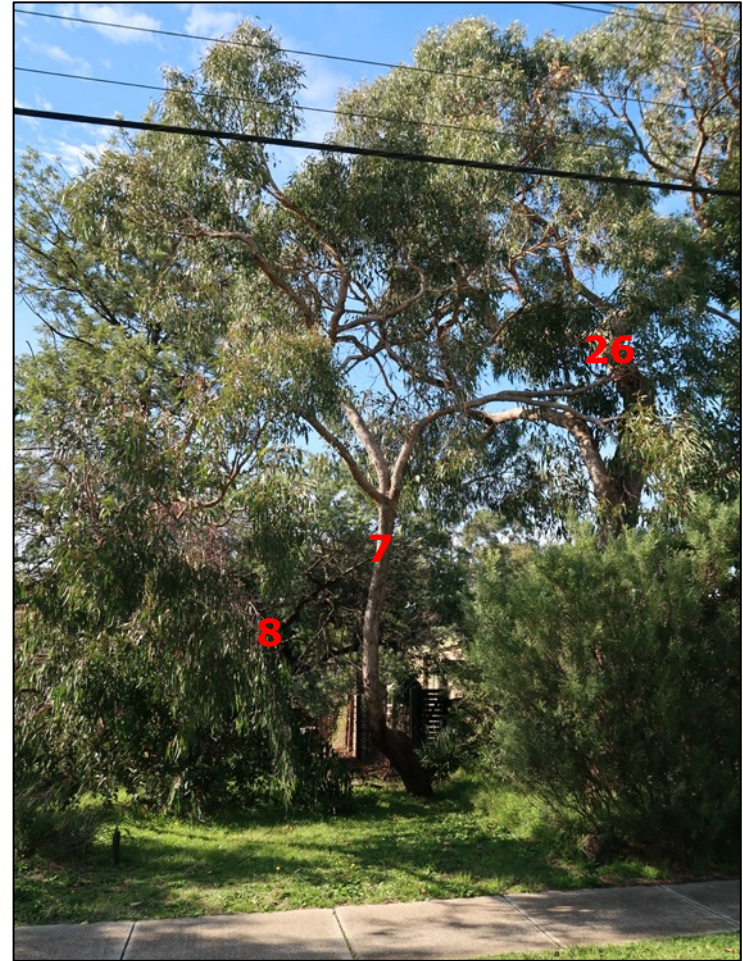
Photo Four: Trees 7 & 8 require removal for a new driveway, **Tree 26** must be retained and protected.

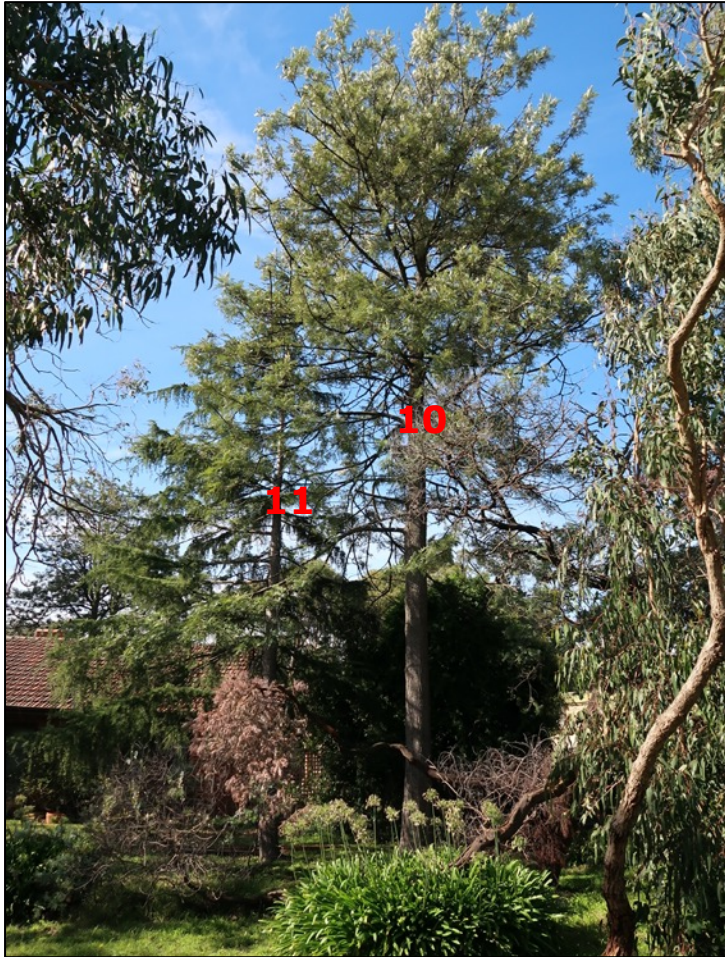
Photo Five: Trees 10 & 11 are semi-mature specimens suited to retention but their location restricts site development substantially.

Tree 10 is a semi-mature Silky Oak, **Tree 11** is a semi-mature Himalayan Cedar. Both are of good condition and well suited to long-term retention of both trees would be preferred given their current stature and long-term potential, but their central location on the site makes this a major limitation to development. **Tree 11** is also incongruous with a mostly native landscape on/near the site. **Trees 2 & 16** are being retained and some new canopy trees are proposed, so removal of **Trees 10 & 11** is considered a reasonable compromise.

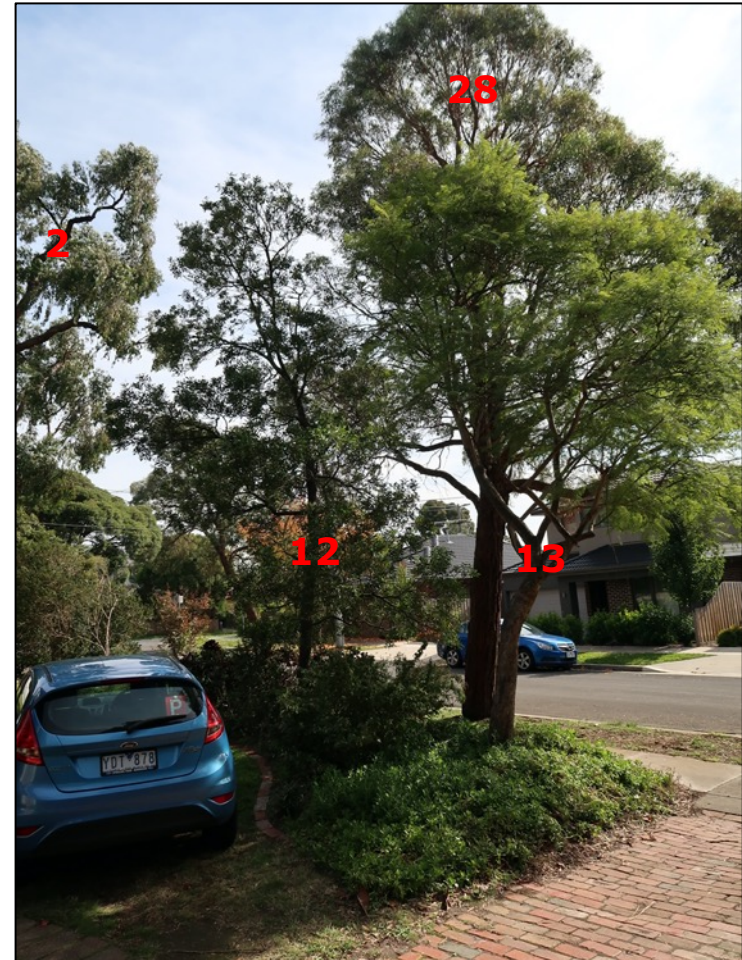
Photo Six: Trees 12 & 13 showing minor landscape contribution at present, but Tree 13 has good long-term potential and will be retained.

Trees 13-15 are relatively small exotic trees of low amenity value (See Photo Six). All are suitable for long-term retention, but only **Tree 13** has potential to increase in amenity value significantly and will be retained. **Tree 13** requires protection from driveway works and general construction activity (See Recommendations & Appendix 2). **Tree 14** is being mildly suppressed and is structurally inferior. **Tree(s) 15** would be difficult to retain during demolition and may be structurally compromised once the existing dwelling is removed. Removal of **Trees 14 & 15** is considered reasonable to facilitate works and new landscaping.

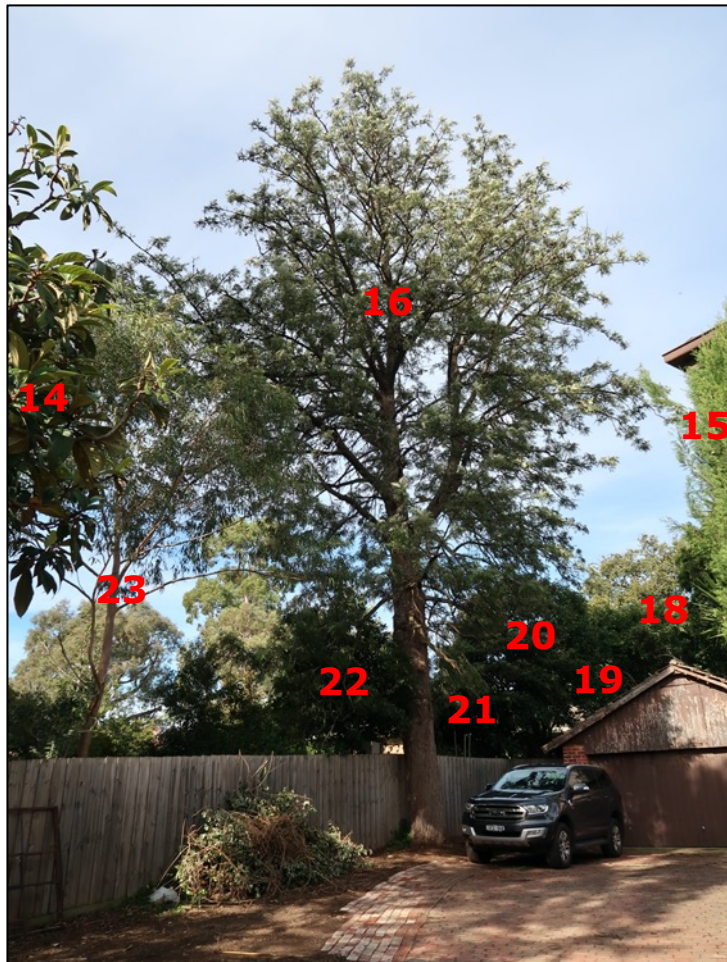
Photo Seven: Tree 16 showing desirable condition, large landscape contribution, and existing features in the TPZ.

Tree 16 is a mature Silky Oak of good condition (See Photo Seven). This is the dominant tree of the site, adding substantial landscape character to the vicinity. Despite being in an easement, retention is recommended. Shallow roots are evident from raised areas in the brick driveway.

Tree 16 incurs a TPZ encroachment from the Unit 1 of approx. 20%, the car space and other landscape works may cause additional disturbance. With preservation of existing levels and use of low-impact footings/surfacing (e.g. waffle pod and above-grade paving), **Tree 16** should not be compromised. However the amenity value, degree of encroachment and extent of works in the TPZ warrants mulching and irrigation where feasible to offset any root damage (See Recommendations & Appendix 2).

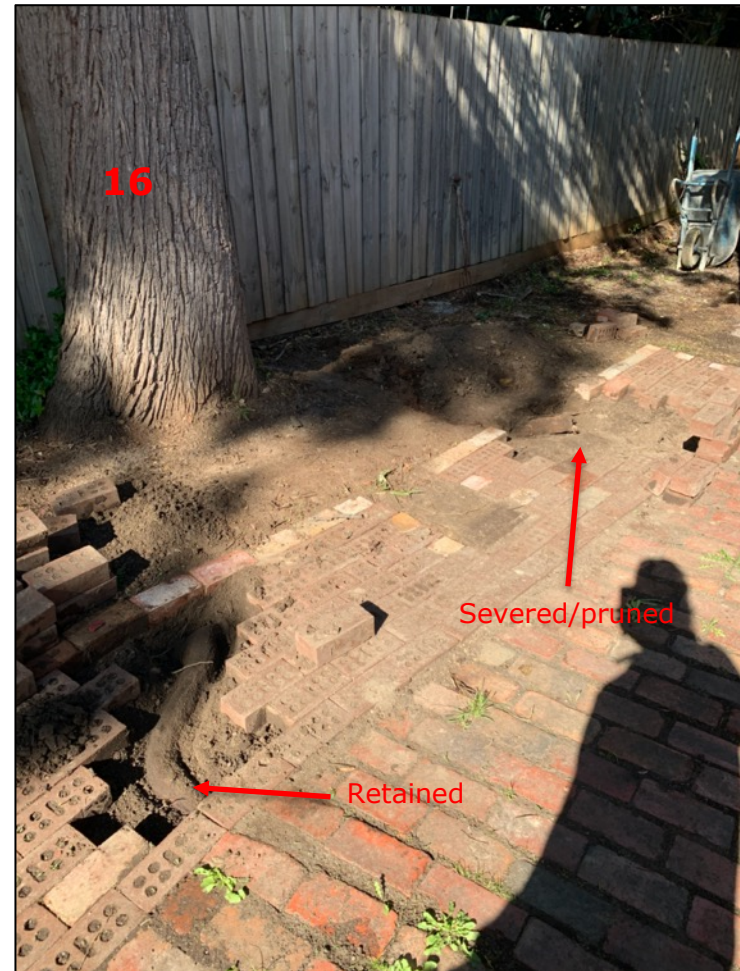
Photo Eight: Tree 16 had one large root severed (and later pruned), another was exposed but was undamaged. This tree requires diligent protection to maintain viability.

The client widened the driveway shortly before the initial inspection, severing several roots from **Tree 16**. Following concerns over total tree failure, a second inspection was conducted to quantify root damage and structural integrity. One large/structural root roots extending towards the garage was severed (approx. 105mm diameter), another less significant root (approx. 45mm diameter) was also torn, both roots were pruned to promote wound sealing (See Photo Eight). Another large/structural root extends towards the dwelling but was not damaged. Long-term retention is considered appropriate because root damage was not as excessive as indicated by the client.

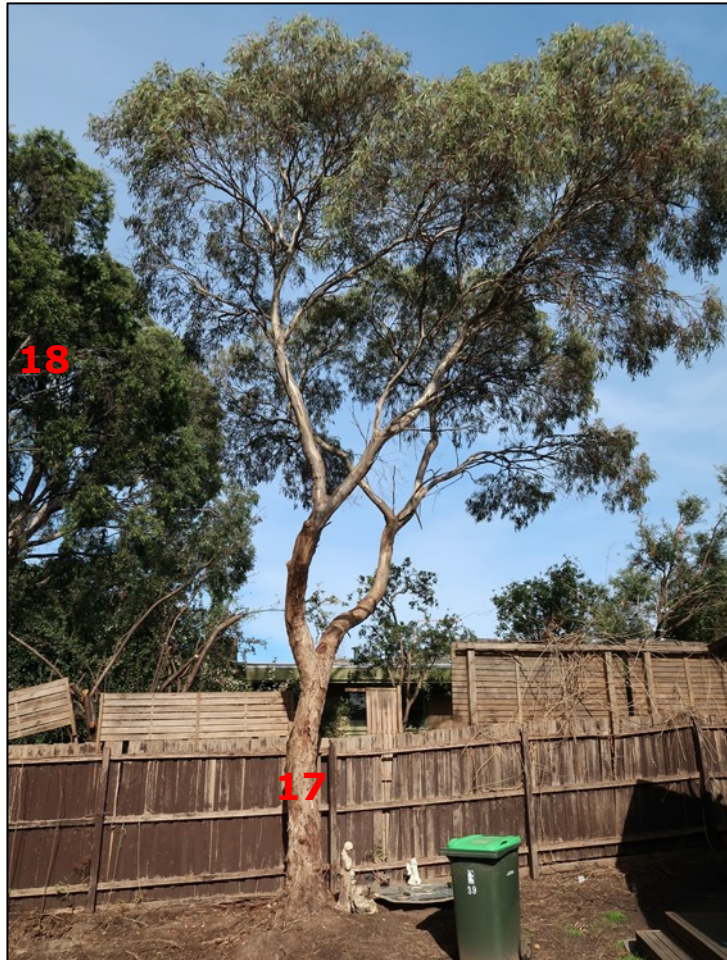
Photo Nine: Tree 17 showing general condition, architecture, landscape contribution, and proximity to boundary. Removal and replacement is proposed.

Tree 17 is a mature Yellow Gum of good-fair condition (See Photo Nine). Removal of weedy undergrowth was co-ordinated with minor uplift pruning. **Tree 17** is a substantial landscape addition with good long-term potential. Unit 1 just infringes the TPZ (approx. 2%), decking and paving are in the SRZ. Retention was initially intended, but a site cut is now proposed to mitigate issues with levels at the entrance of Unit 1 - making removal of **Tree 17** necessary. Removal of **Tree 17** will further reduce landscape character of the site, so design alternatives were discussed/investigated. Removal of **Tree 17** as proposed have been offset within plans via inclusion of another medium sized native canopy tree, which can offset then loss in time.

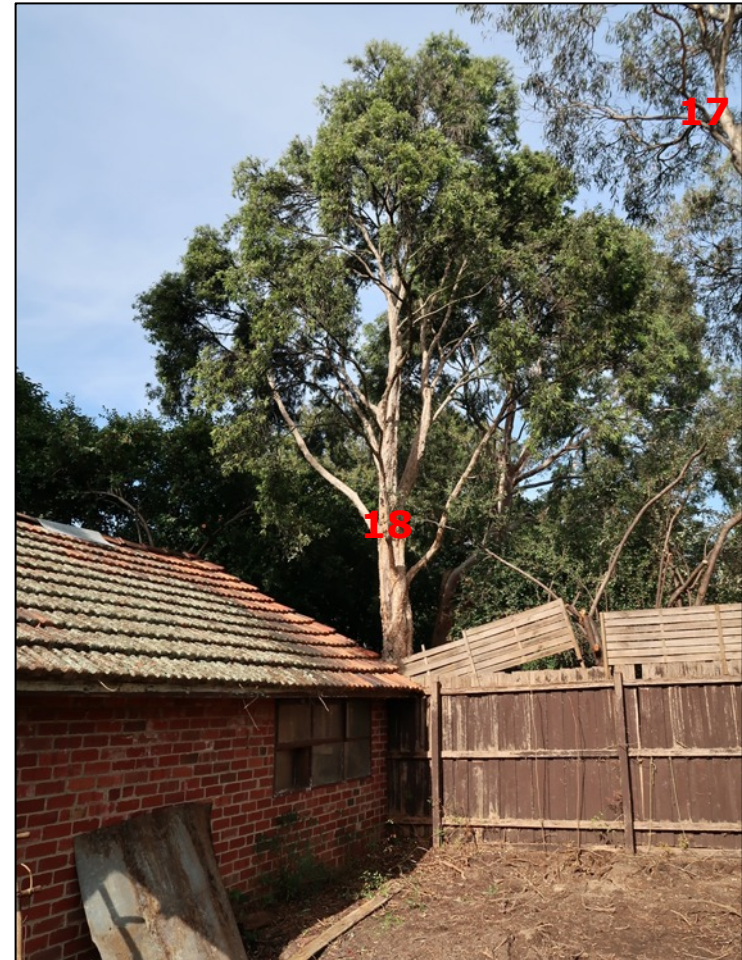
Photo Ten: Tree 18 is unlikely to be compromised because the existing shed is expected to have restricted root mass within the site.

Tree 18 is a mature Willow-leaf Callistemon of fair-poor condition (See Photo Ten). The existing garage is likely to be restricting most roots entering the subject site, so the proposed site cut and retaining wall in the SRZ are not expected to compromise tree viability. With care during demolition and protection of the area between the retaining wall and boundary, **Tree 18** is expected to tolerate works (See Recommendations & Appendix 2).

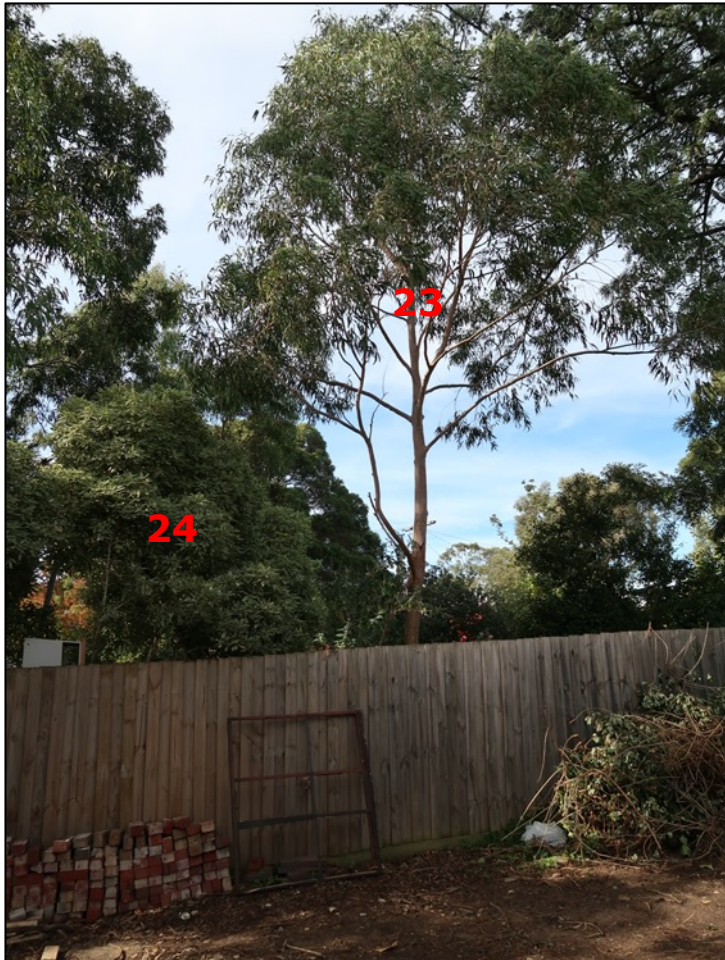
Photo Eleven: Trees 23 & 24 require TPZ protection.

Tree(s) 23 represents two semi-mature Lemon-Scented Gums of fair condition (See Photos Seven & Twelve). Both appear suitable for long-term retention. Neither incur a TPZ encroachment from Unit 1 or its driveway, but landscape works (e.g. Lilydale toppings) warrant careful installation. Protection from indirect disturbance is recommended (See Recommendations & Appendix 2).

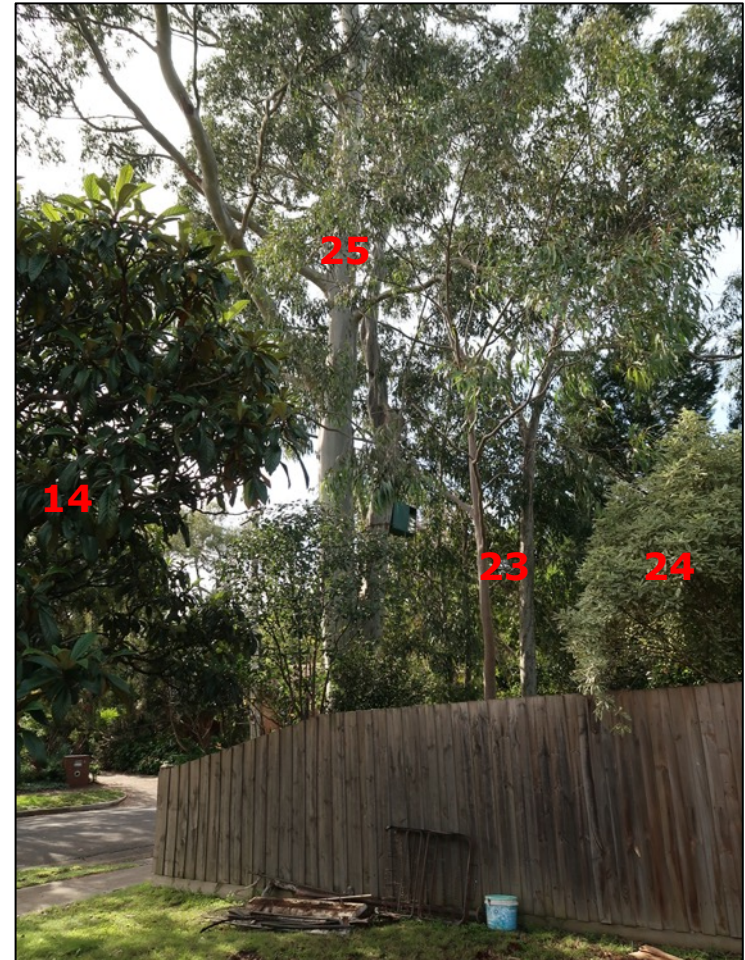
Photo Twelve: Tree 25 is a dominant tree, which should tolerate works with protection.

Tree 25 is a mature Spotted Gum of good-fair condition (See Photo Twelve). This is a dominant tree of the vicinity, extensive root spread is expected within the subject site. Its species and condition indicates a good tolerance to disturbance/wounding.

Tree 25 incurs a minor encroachment from the required driveway, gravel surfacing in the easement has potential to cause root damage. Surfacing within the TPZ is recommended to be installed above-grade, although it is probable **Tree 25** would tolerate some shallow excavation. Protection of the TPZ area is recommended (See Recommendations & Appendix 2).

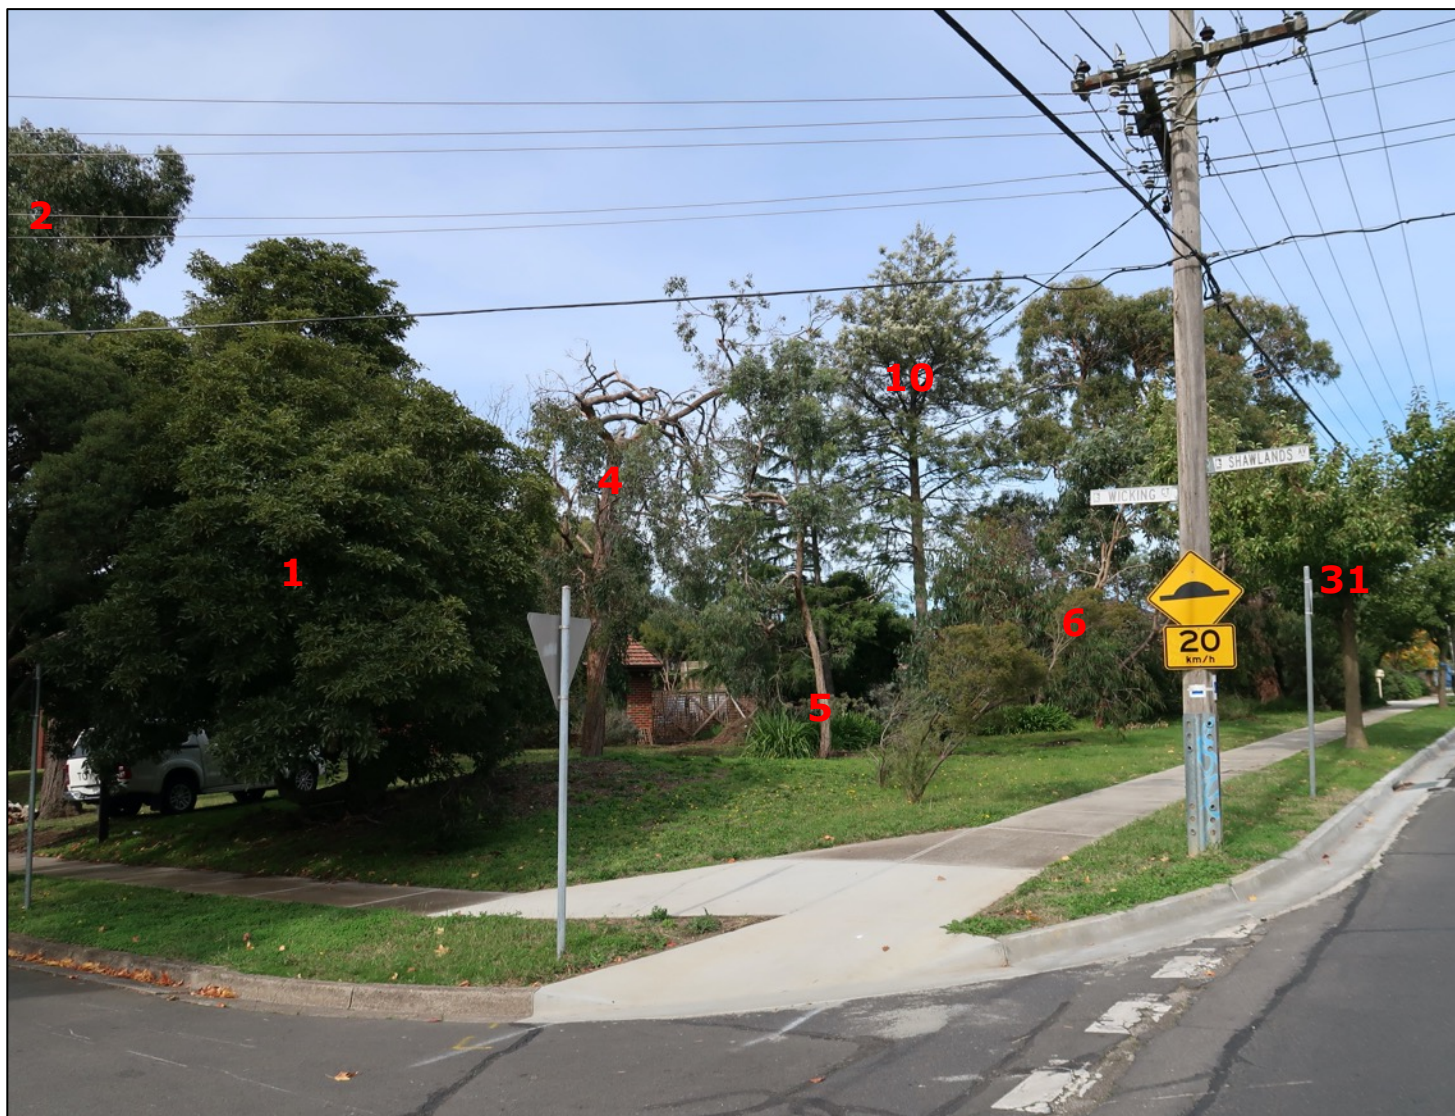
Photo Thirteen: Showing site from intersection. **Tree 31** requires removal for a new crossover.

Tree 31 is a moderate specimen, but has a limited ULE and is conflicting with line clearance requirements (See Photo Thirteen). A new crossover is proposed within its SRZ of **Tree 31** (conflicting with typical 3m setback policy). Removal is considered necessary, although supervised excavation may allow it to be retained. Removal is supported here given the species and replaceability. Capacity for several new street trees on the Holland Rd frontage exists.
