### 9.2.1 Electric Line Clearance Compliance: Street Tree Management

**Whitehorse CC ELC System Audit Report**

## Electricity Safety (Electric Line Clearance) Regulations 2015 – System Audit Report for the City of Whitehorse

## 9.2.1 – ATTACHMENT 2. ELC LBRA Inspection Report

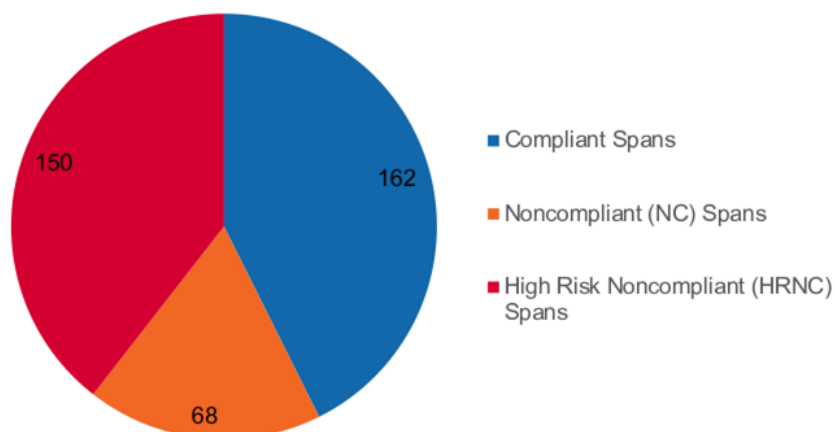
**Figure 3: Classification of inspected spans**

ESV inspected a total of 380 spans. Of these spans, 218 were found to be affected by vegetation that did not comply with the requirements of the code and where the City of Whitehorse is responsible for maintaining the minimum clearance space.

The number of compliant and noncompliant spans where the City of Whitehorse is the responsible person is shown in Figure 3.

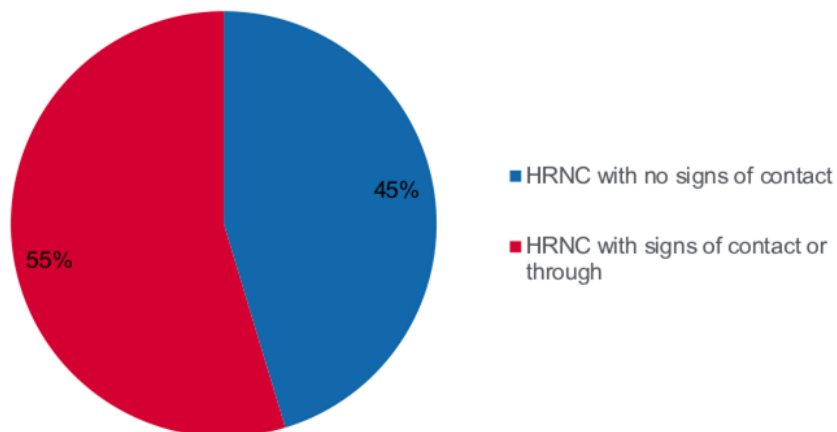
Figure 4: The percentage of HRNC spans in contact with an electrical line

The percentage of HRNC either contacting, with signs of having contacted an electrical line or growing in between two conductors is shown in Figure 4.

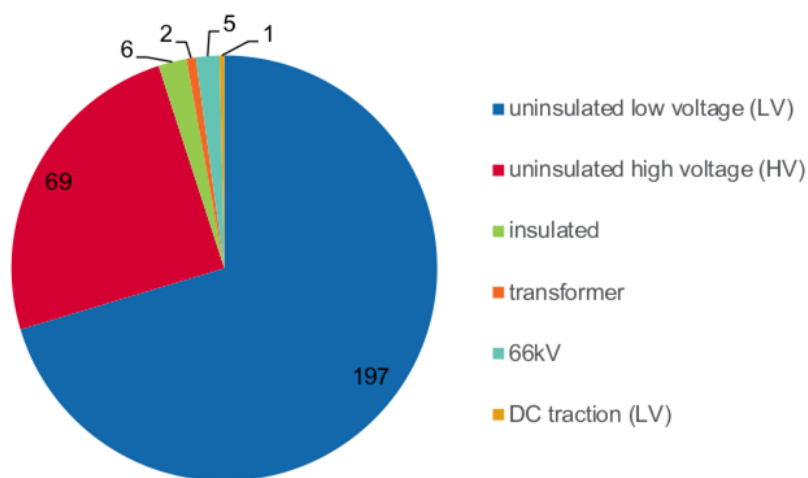
**Figure 5: Voltage of noncompliant spans**

The percentage of the types of electric lines affected by noncompliant vegetation is shown in Figure 5.

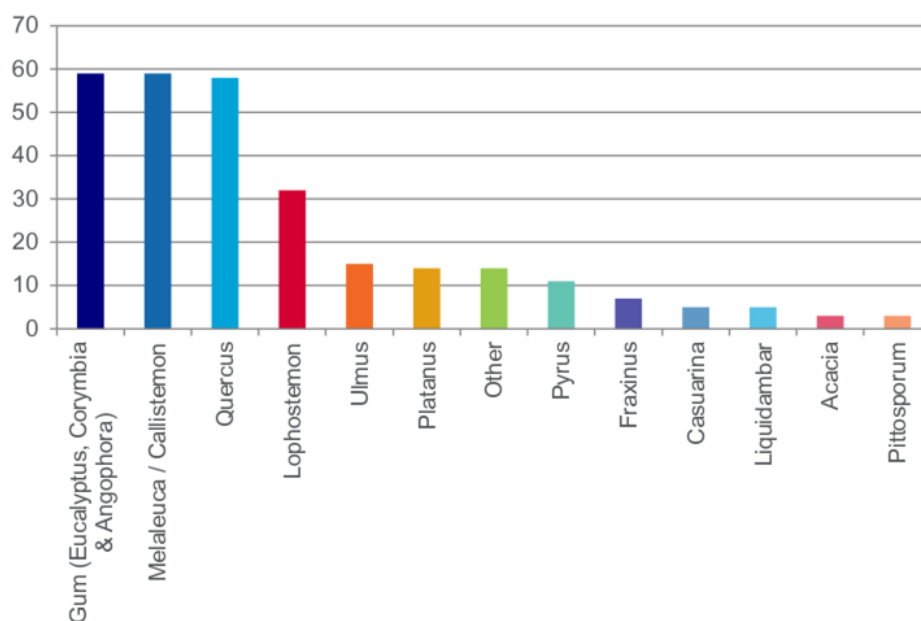
Figure 6: Instances of City of Whitehorse noncompliance by Genus

Vegetation from the Gum (*Eucalyptus*, *Corymbia* and *Angophora*) and the *Melaleuca*/*Callistemon* genera represented the largest groups of noncompliant vegetation. A summary of noncompliant vegetation by genus is shown in Figure 6.
