Arboricultural Report

(Development Impact Assessment)

For the Proposed Development of
39-41 Holland Road,
Blackburn South 3130

23rd September 2020

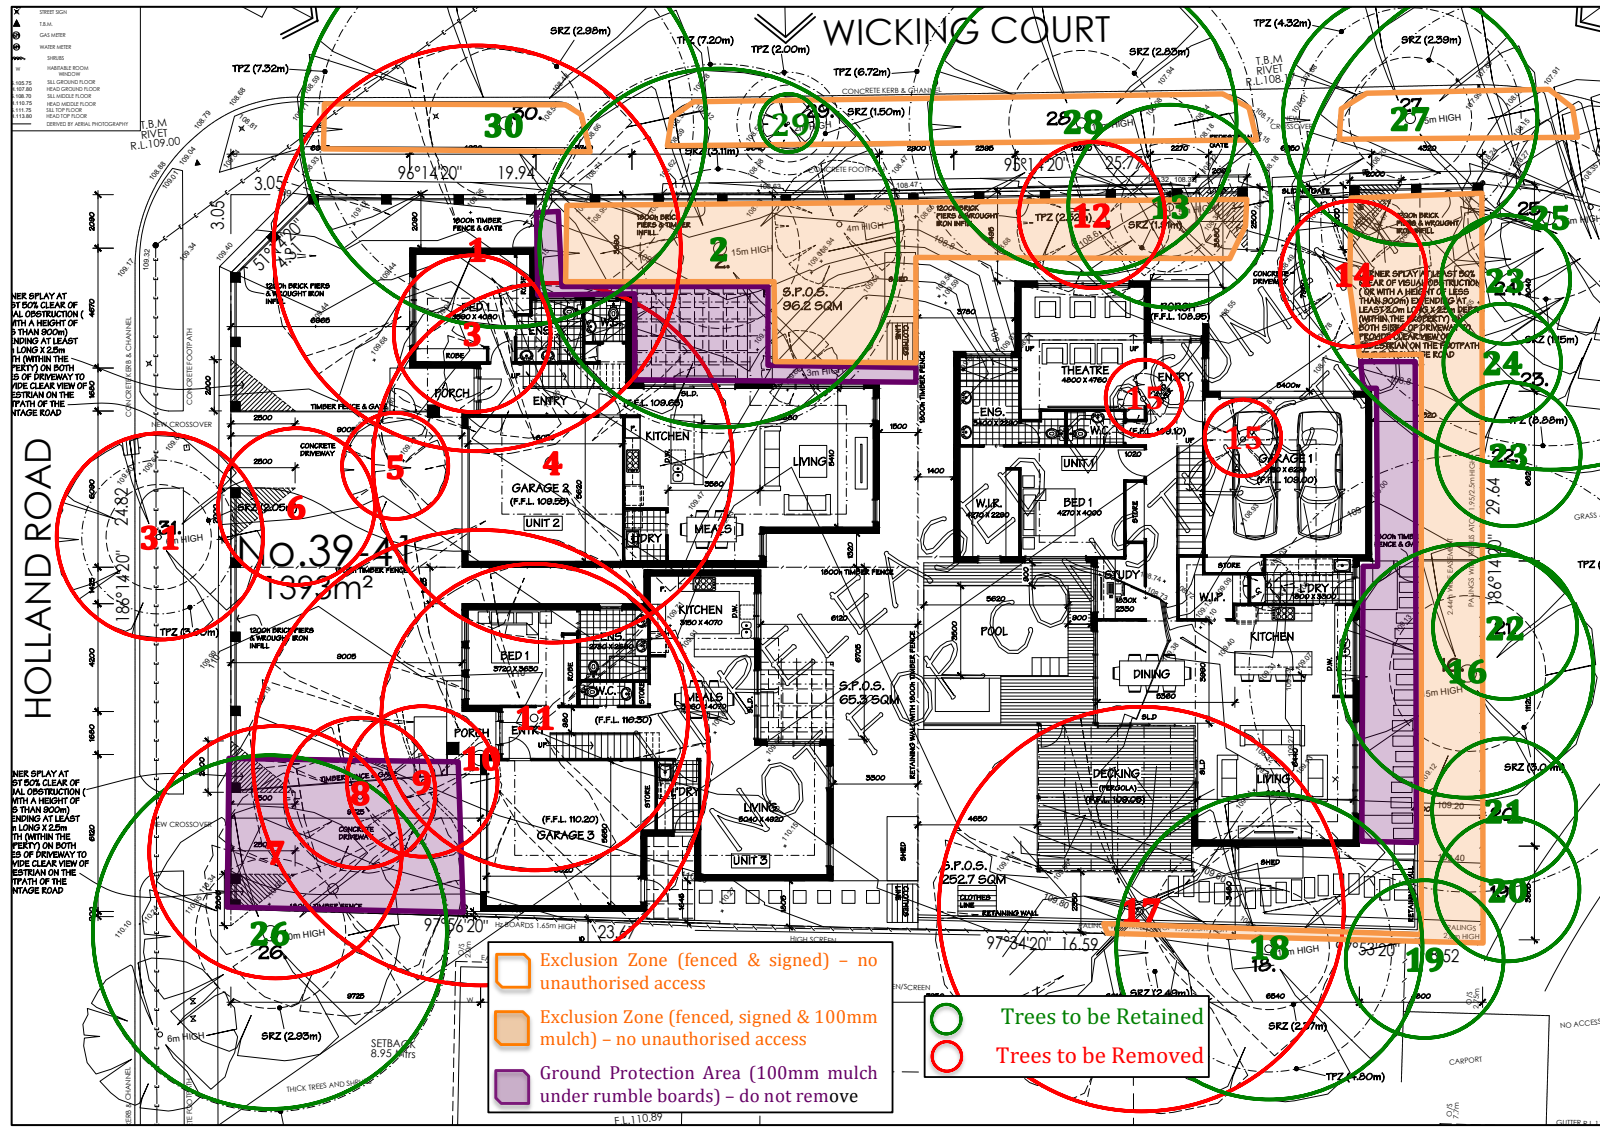
Appendix 2: Design Response, Tree Locations & Protection Areas

- Two trees (**Trees 5 & 6**) incur no encroachment from the development proposal
- One tree (**Tree 13**) incurs a minor encroachment from the development proposal
- Fourteen trees (**Trees 1-4, 7-12 & 14-17**) incur a major encroachment from the development proposal
- Fourteen trees (**Trees 1, 3-12, 14, 15 & 17**) are required/recommended for removal
- Three trees (**Trees 2, 13 & 16**) require protection during works

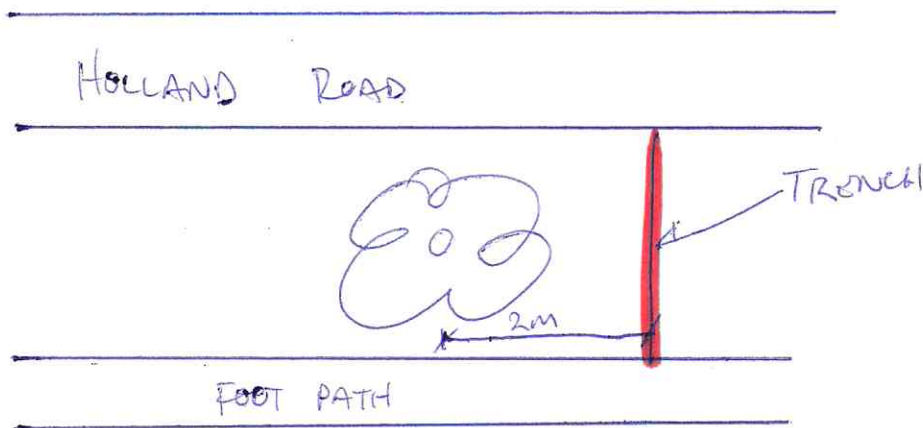
Site Address	39-41 HOLLAND ROAD BLACKBURN SOUTH		Crew on site	Damien	Marcus	
Tree Species						
Additional Traffic Management Required	yes	no	Start time	7.30am	Finish time	11.30am
<p style="font-size: 24px; color: blue;">No Roots Found</p>				<p>Works description</p> <p>Tree root investigation along red line</p> <p style="font-size: 24px; color: blue; text-align: center;">LOCATION (2)</p>

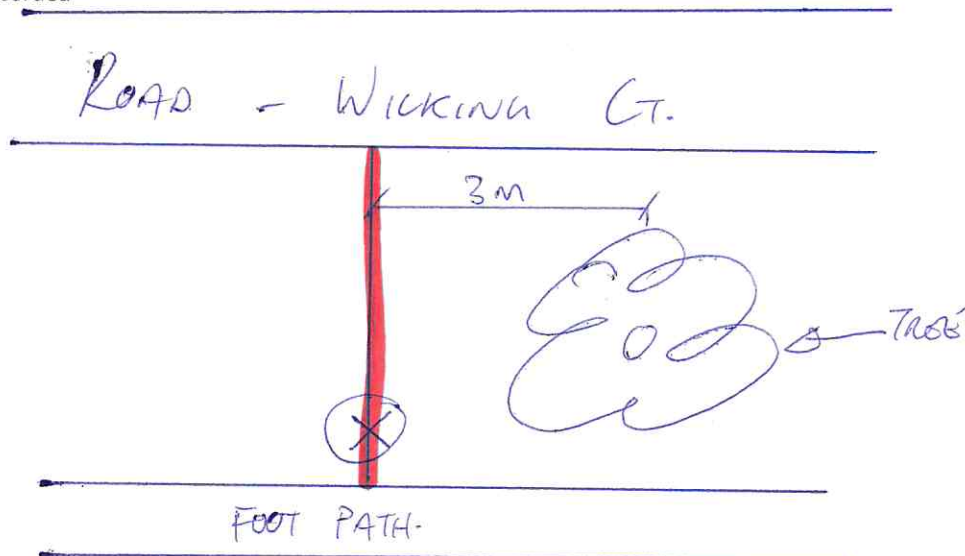
Site Address	39-41 HOLLAND ROAD BLACKBURN SOUTH		Crew on site	Damien	Marcus	
Tree Species						
Additional Traffic Management Required	yes	no	Start time	7.30am	Finish time	11.30am
<p style="font-size: 1.2em; color: blue;">Small Root 2mm in size.</p>				<p>Works description</p> <p>Tree root investigation along red line</p> <p style="font-size: 1.5em; color: blue; text-align: center;">LOCATION ③</p>
